# Manhole Inspection Summary

Manhole # S47K2\_002MH

Insp Date: **1/15/08 10:08 AM**

**Location** Address: **Benhill Ave**

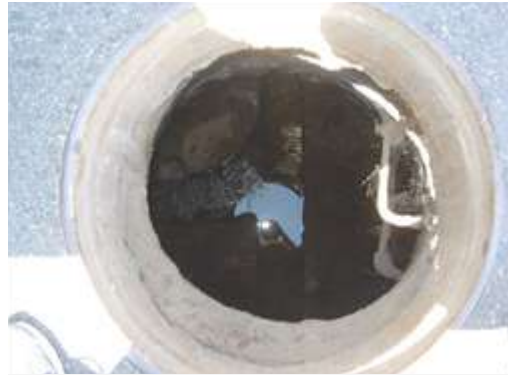
Top View

Comments **cover cracked (no imprints on manhole. plain face cover)**

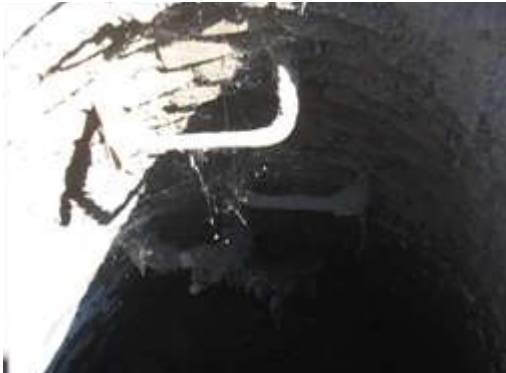
Steps

**Steps** Count: **4** Missing: **0** ☒ **Corroded**

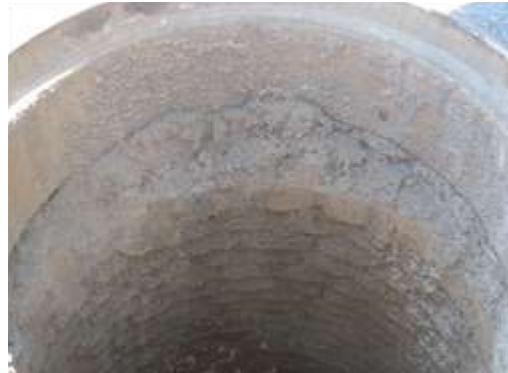
Defect 1

**Frame** Offset: **2** (in.) Condition: ☒ Sound ☐ Cracked ☐ Leaks

Frame offset

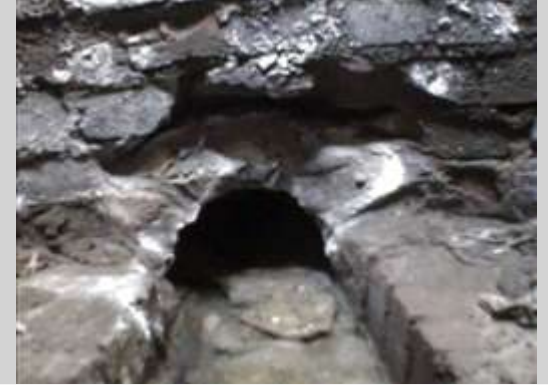
12 O'Clock Outflow

Pipe Height: **8.4** (in.) Rod and Bar (Angled)  
Pipe Material: **Clay** ☐ Pipe Lined  
Invert Depth: **8.30** (ft.) Flow Characteristics: **Slow**  
Deposits: ☐ None ☐ Mud ☐ Sludge ☒ **Debris** ☐ Grease  
Silt Depth: **4** (in.) Deposits Extent: **Heavy**  
Infiltration: **None** Pipe Seal Cond: **Broken**

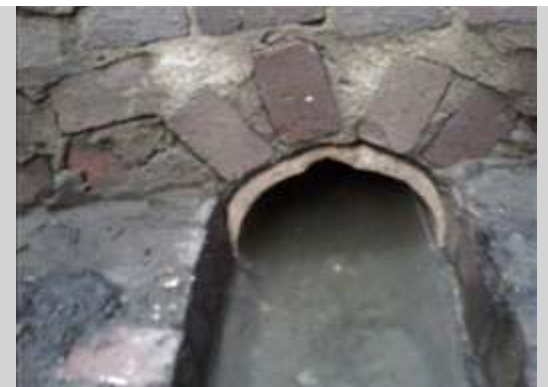
6 O'Clock Inflow

Pipe Height: **8.4** (in.) Rod and Bar (Angled)  
Pipe Material: **Clay** ☐ Pipe Lined  
Invert Depth: **8.20** (ft.) Flow Characteristics: **Slow**  
Deposits: ☐ None ☐ Mud ☐ Sludge ☒ **Debris** ☐ Grease  
Silt Depth: **5** (in.) Deposits Extent: **Medium**  
Infiltration: **None** Pipe Seal Cond: **Sound**

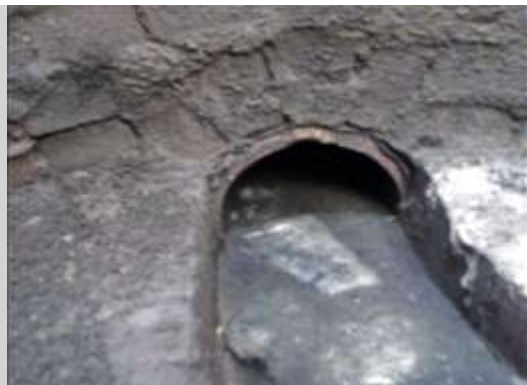
9 O'Clock Inflow

Deposits: ☐ None ☐ Mud ☐ Sludge ☒ **Debris** ☐ Grease

Silt Depth: **4** (in.) Deposits Extent: **Medium**
